LOWER MISSISSIPPI - ST. FRANCIS BASIN

LAKE KILLARNEY
IRON COUNTY, MISSOURI
MO 30012

PHASE 1 INSPECTION REPORT NATIONAL DAM SAFETY INSPECTION

LAKE KILLARNEY DAM
IRON COUNTY, MISSOURI

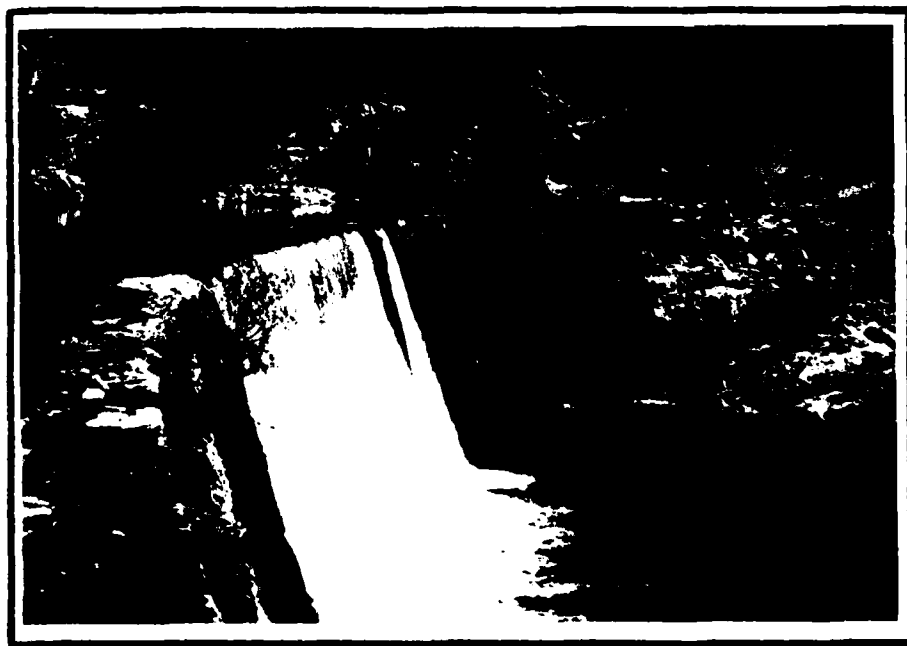
Photograph No. 2

Left abutment of dam.
